# Reliability Failure induced by the Si Epitaxy Growth on PMOS High Voltage Oxide in 0.15um Embedded Flash Memory Devices

Sang Hyun Han, Nam Sung Kim, Madhusudan Mukhopadhyay,  
Wing Yew Wong, Dong Ju Son and Inn Swee Goh

Systems on Silicon Manufacturing Company Pte. Ltd.

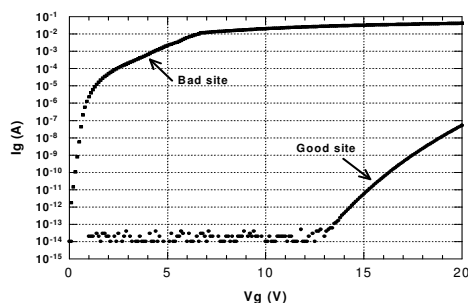
Test showed that out of the four different gate oxides in these embedded Flash devices, Qbd degradation took place in the thickest oxide, which was the HV oxide (210A). This is of special interest as normally the thick oxide is more susceptible to the impact ionization. A further test was done, and the I-V measurement on the degraded oxide showed the oxide breakdown (Fig. 1). Failure Analysis was also performed using Transmission Electron Microscopy (TEM) to identify the breakdown mechanism. Surprisingly, it was discovered that it was Si epitaxy growth on the HV oxide which resulted in the oxide breakdown. (Fig. 2) In addition, the Co silicide, which is generally found at the top of the poly, was found to be missing. Interestingly, the location of the missing Co silicide directly corresponds to the newly discovered Si epitaxy growth.

Fig. 1 Gate current vs. gate voltage at bad and good sites.

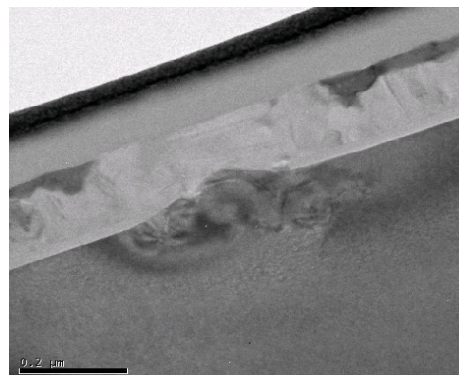
From the experimental results, it was confirmed that the unusual Si epitaxy growth on PMOS HV oxide is attributed to the process-induced stress.

Fig. 2 Si epitaxy growth on PMOS HV oxide.

For the first time ever, the possible mechanism of stress-induced Si Epitaxy growth on HV oxide will be reported, and we will share the process solution to prevent the reliability failure on HV oxide in the charge pump of 0.15um embedded Flash devices.
